# Mercury Bay Student Aviation Trust

## RV12 Project Log

Date	Hours	No. of students	Job reference
26 <sup>th</sup> August 2020	12:30-17:00	6	Engine Work and the Empennage Section

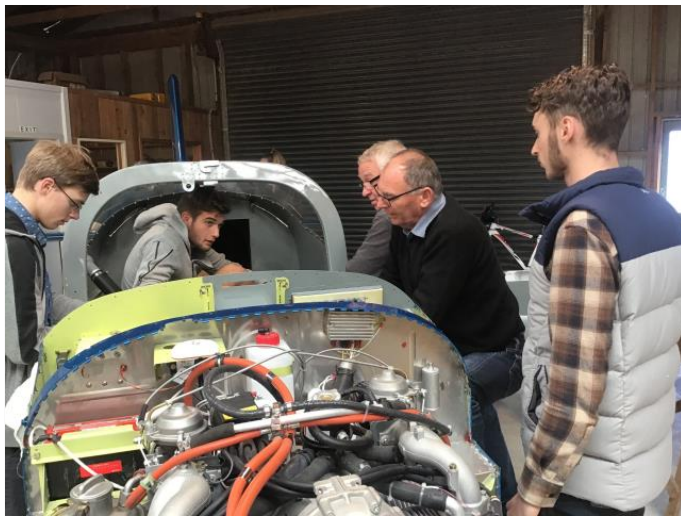
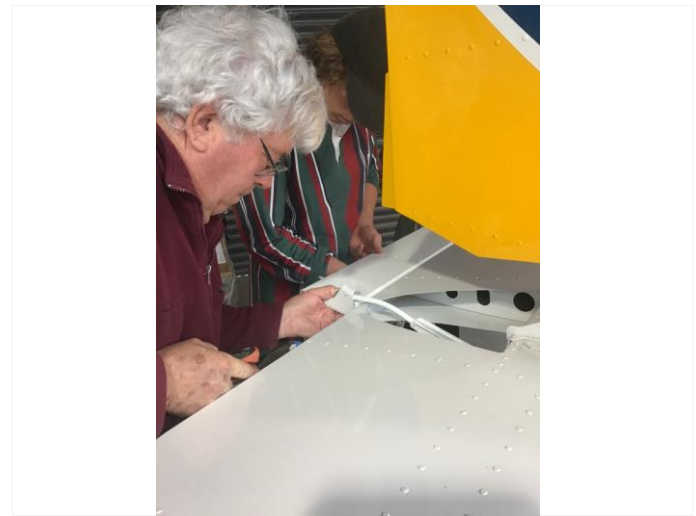
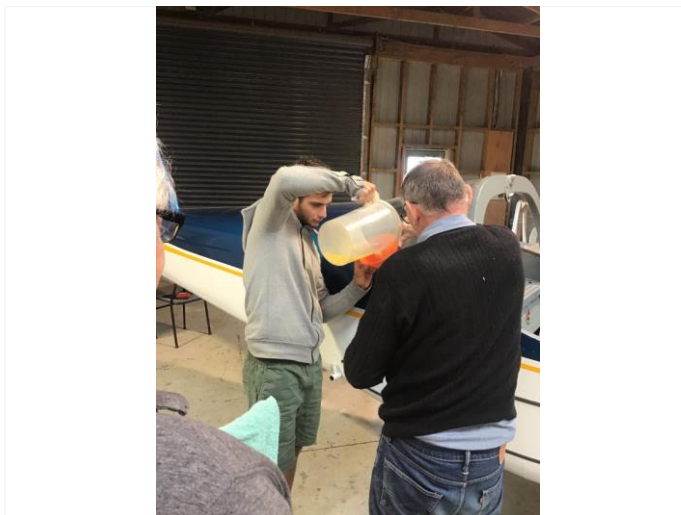
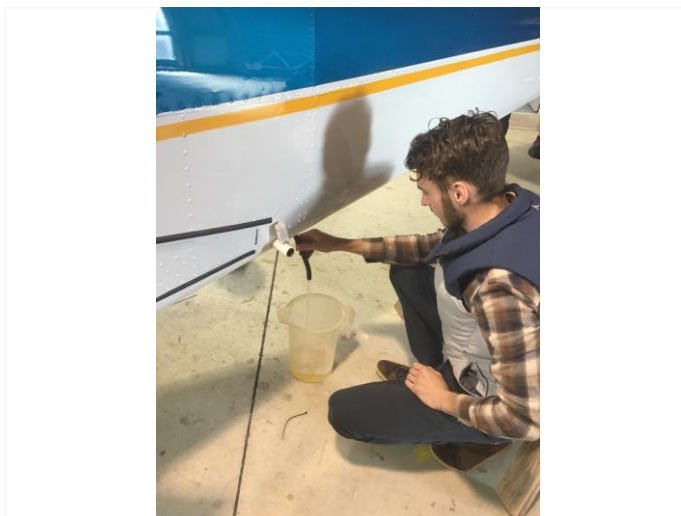
We have been waiting for the trim tab to arrive back from the painters. Once that was completed, we have been able to place it on the tail section. This tab will help reduce forward/backward pressure on the control column. There was a problem with the wiring, where the trim tabs movement was back to front. We needed to check the Mercury Bay Aero Club's RV-12 to verify that what we had was correct or not. However, this is now being resolved as we did some rewiring to operate in the correct direction.

Today, Corbin had the task of placing the wheel fairings onto the front wheel of the plane. By doing this, the wheel will be protected by any damage and will allow more of an aerodynamic shape. They also look amazing in blue!
