# Mercury Bay Student Aviation Trust

## RV12 Project Log

Date	Hours	No. of students	Job reference
19 <sup>th</sup> August 2020	12:30-17:00	3	Reassembly after painting.

### Assembling ZK-MBB after Painting

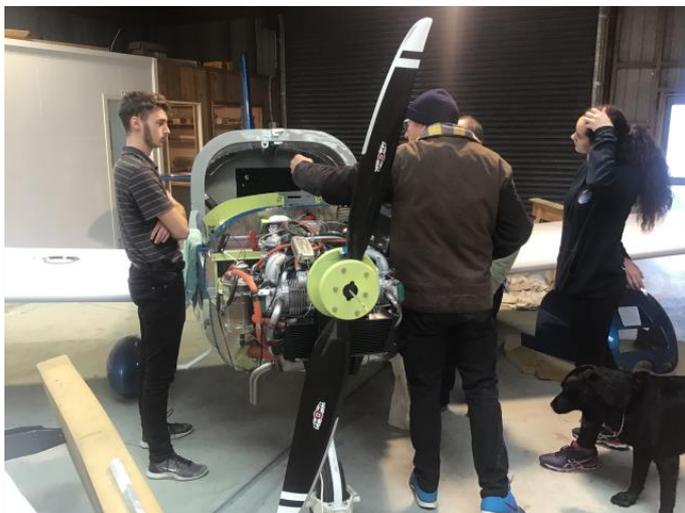
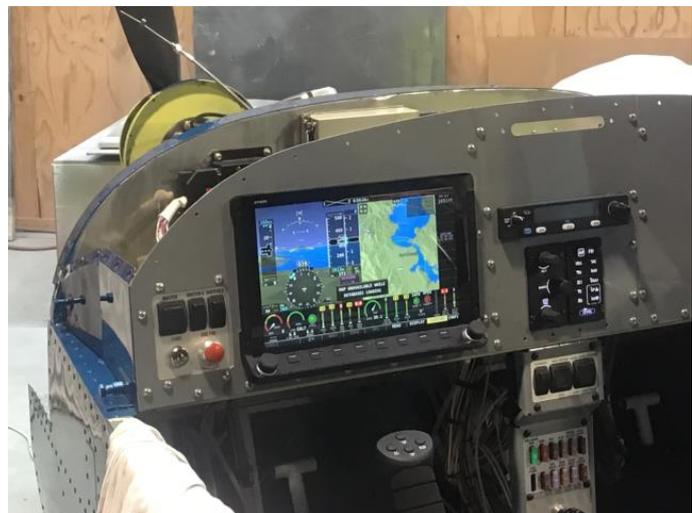
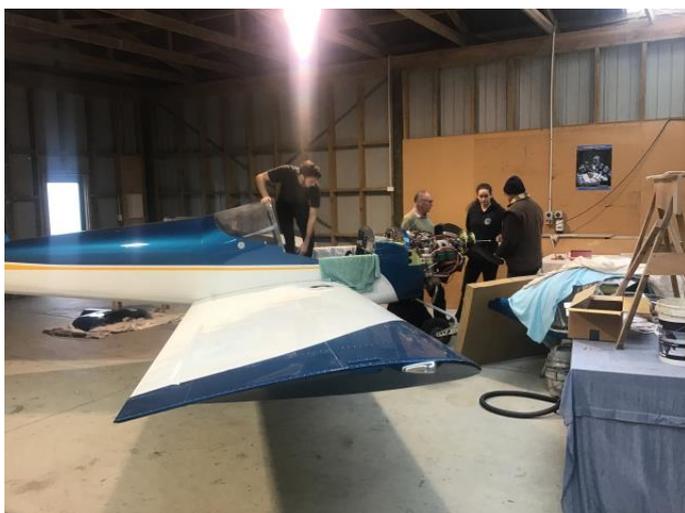
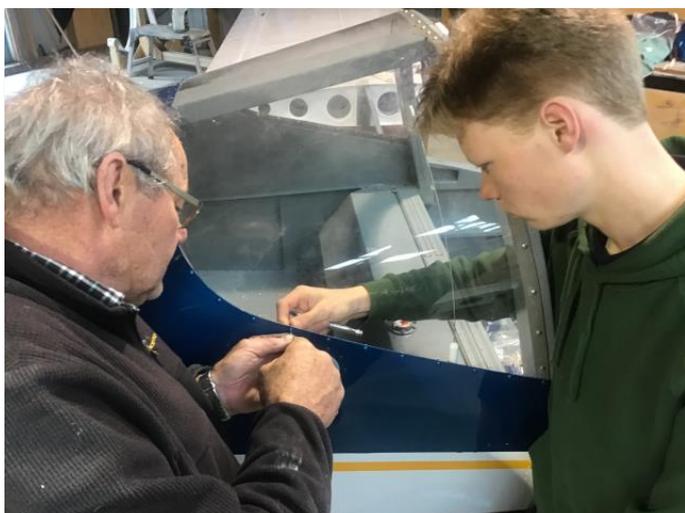
Today the list of jobs is full of small tasks. However there are plenty of them. First up Cara, Kal and Tony were fitting the propeller. This involves setting the pitch with a special tool, then carefully and methodically tightening the bolts with a torque wrench. This process takes time to get it perfect, once this was achieved Kal went about finding the components to re-fit the spinner to the front of the aircraft.

The wings were removed and trimmed again, so that they fit perfectly with the fuselage. Floyd and Kal then set about fitting the tapered foam sealant to the fuselage, so that when the wings are slid in place there is an air tight seal to the fuselage.

Cara has been battling away to fit the nose landing gear leg fairing. It is a tricky spot to get the rod, which locks the hinge together, in place. With patience and perseverance the job was soon completed.

Kal was tasked with giving the cockpit area another vacuum. We are doing our best to keep everything as clean and tidy as possible as we move closer to completion. Floyd then secured the radio antenna to ensure there is no rubbing on the rear canopy plexi glass. In order to finalise the cockpit wiring, all cables are followed and checked that they run through the correct pathways before finally securing them with cable ties. It now looks very tidy and very professional – a big difference to when we were first started running the wiring loom!

Cara and Bob were cutting holes in the rear wheel fairings. They will be covered up with rubber plugs to complete the tidy look. This is to gain easy access to put air in the tyres as needed.
